ENGINEERED OXIDE NANOFILMS PREPARED FROM SOLUTIONS AT RELATIVELY LOW TEMPERATURES

Arvid Pasto¹, Michael Pozvonkov¹, Morgan Spears¹, Evan Hyde², and Mark Deininger¹

¹ C3 International, LLC, Alpharetta, Georgia 30004

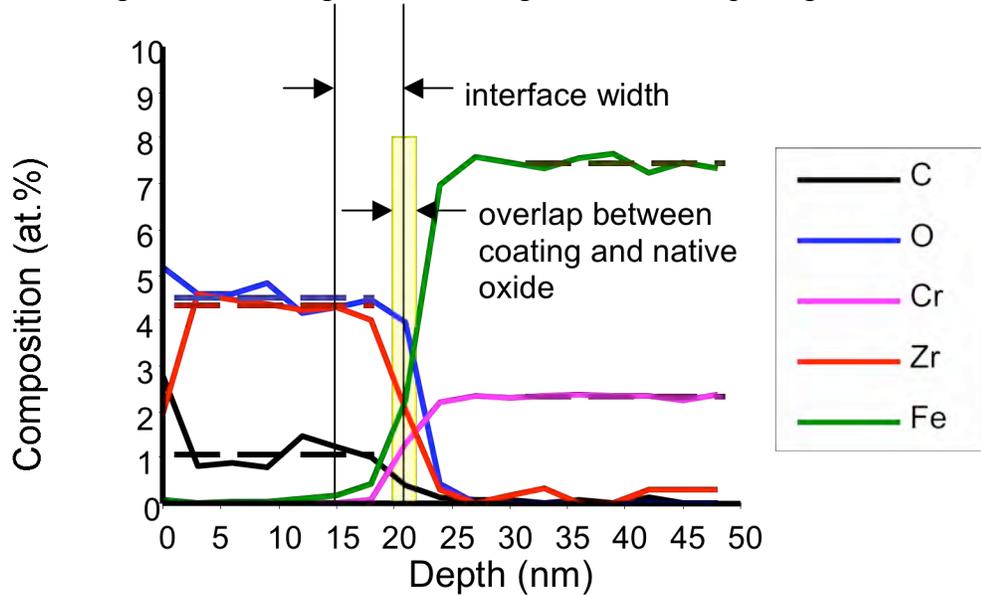
Figure 1. Scanning Auger nanoprobe results on a C3 zirconia film deposited on steel.

Scanning Auger nanoprobe studies (Figure 1), along with transmission electron microscopic analyses (performed at ORNL) of C3's nanofilms (Figures 2 and 3), show an interdiffusion region where the coating layer material has diffused into the substrate, significantly increasing the bond strength and reducing the risk of its spalling off the surface.

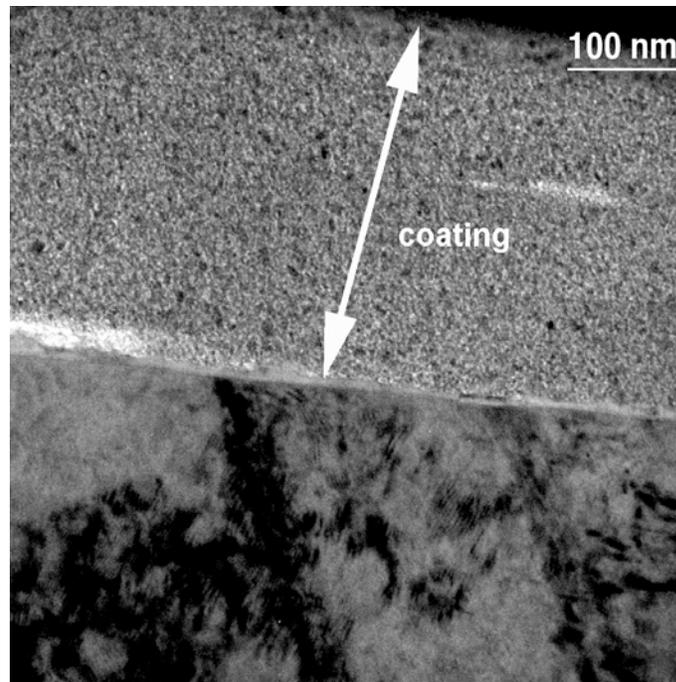
Figure 2. Transmission electron micrograph of a C3 zirconia film deposited on steel. Careful observation will show that there are three layers, resulting from three applications.

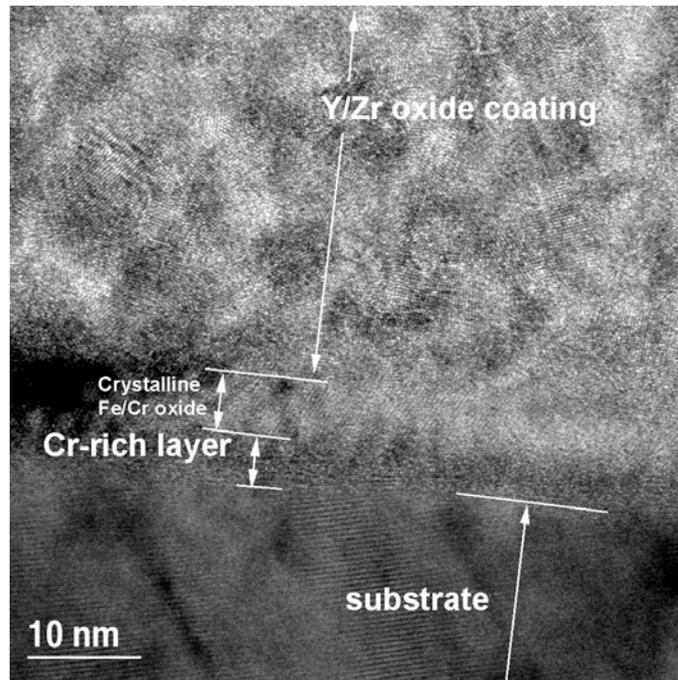
Figure 3. Transmission electron micrograph of a C3 zirconia film deposited on steel. Note the reaction and interdiffusion layer under the film.

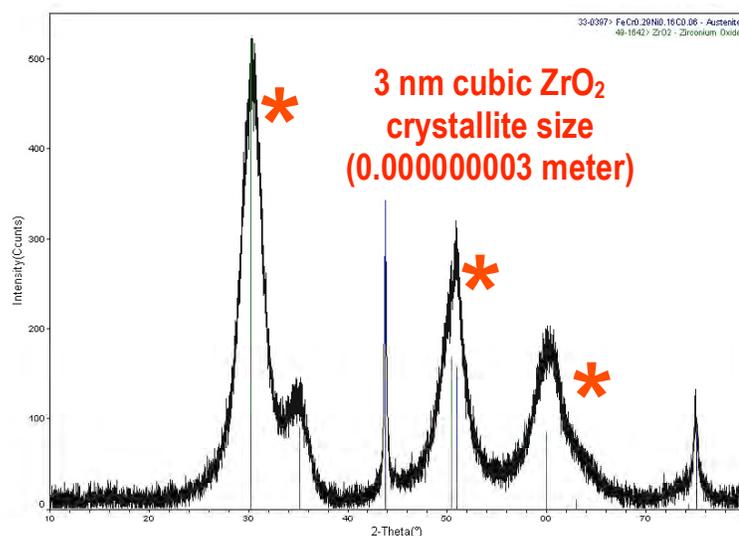
Figure 4. Synchrotron x-ray diffraction pattern of C3 zirconia nanofilm.

Scientists at ORNL noted the crystallites created by our process were 3 to 8 nanometers in dimension. This finding was verified by synchrotron x-ray diffraction analysis performed through the High Temperature Materials Laboratory's (HTML) User Program, with diffraction being performed at the National Synchrotron Light Source at Brookhaven National Laboratory (Figure 4). We believe this small particle size results in extremely strong and dense films, while the interdiffusion region allows for inter-mixing of alloy and film constituents, and subsequently increases the bond strength between the alloy and the engineered nanofilm.

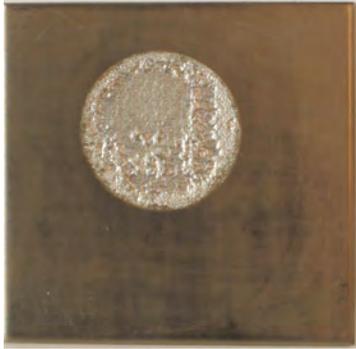
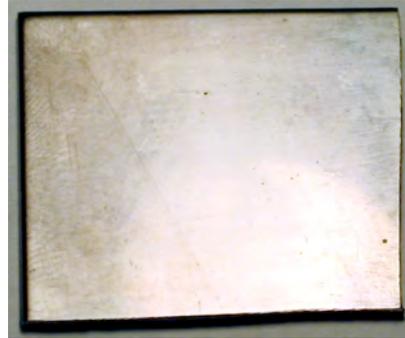
MIST Die Casting Coating

MIST Corrosion Coating

Figure 5. Aqua Regia Test. Sample exposed to specific volume of 3 parts HCl to 1 part HNO₃ for 1 hour. Dark region on left specimen is coating; light region is corrosion area, where film has been eaten through.

Nanofilms have been developed to resist corrosion in several industrial applications. One particular film has been developed which is extremely resistant to aqueous-based corrosion, including aqua regia. (See Figures 5 and 6 below) This same film has been proven to be resistant to elevated temperature salt-spray corrosion.

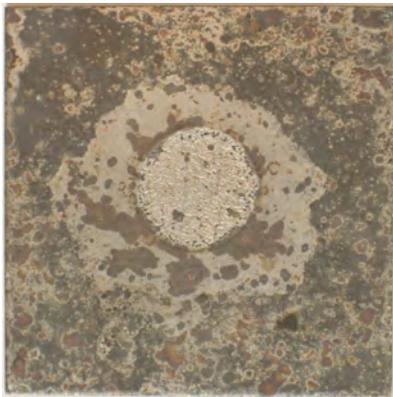
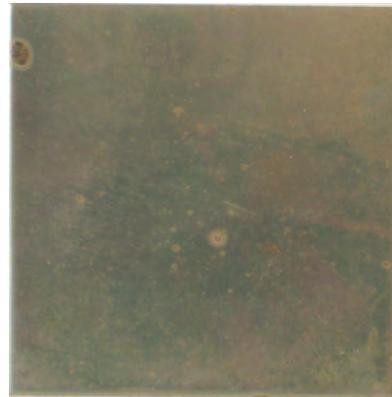
MIST Die Casting Coating

MIST Corrosion Coating

Figure 6. High Temperature Salt Spray Test. Samples heated to 1652°F in air, then periodically sprayed with 10% salt water solution for 1 hour. Circular region on left specimen is corrosion through the film.

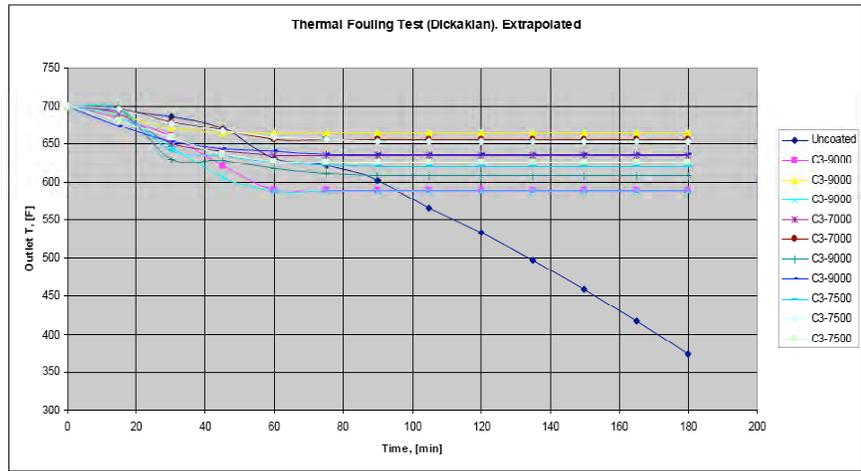
Figure 7. Temperature versus time for residual oil flowing over heater tubes being maintained at a constant internal temperature. Note that the uncoated tube becomes coated with coke and heat transfer is reduced, while all of the C3 coating compositions reach a plateau at which further temperature decay is prevented (e.g., heat transfer is maintained because of lack of fouling by coke).

The test, performed at F.A.C.T. in Houston, by Dr. Ghaz Dickakian, involves circulating residual oil over tubes of standard petroleum refinery alloy, which contain internal heaters held

at constant power level. The temperature of the oil is measured versus time, and, as coke build up on the alloy heater tubes, the temperature of the oil decreases. Several compositions of C3 nanofilms were tested in this apparatus (results below).

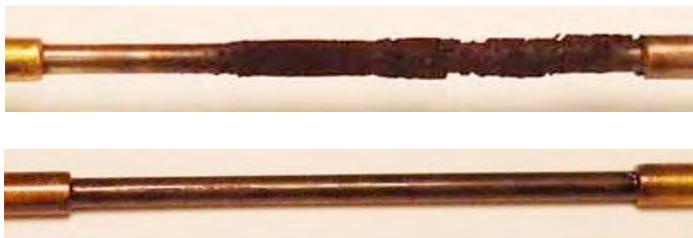
Figure 8. Uncoated (top) and C3 nanofilm coated (bottom) alloy tube exposed to residual oil on the outside, while being heated by heaters inside the tubes. Note that the C3 coated tube has much less, and more uniform, coke buildup.

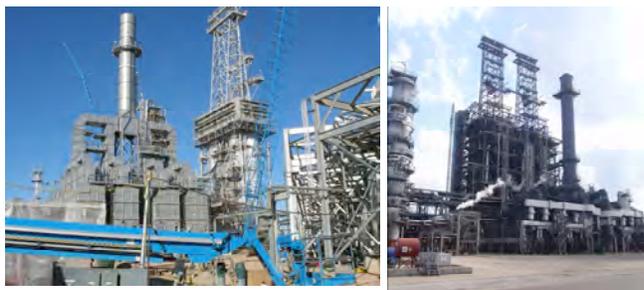
Figure 9. The Frontier Oil Company's (left) and a larger Houston-area refiner's (right) cokers, into whose coker heater tubing C3 has successfully emplaced engineered nanofilms, via in-the-field installation.

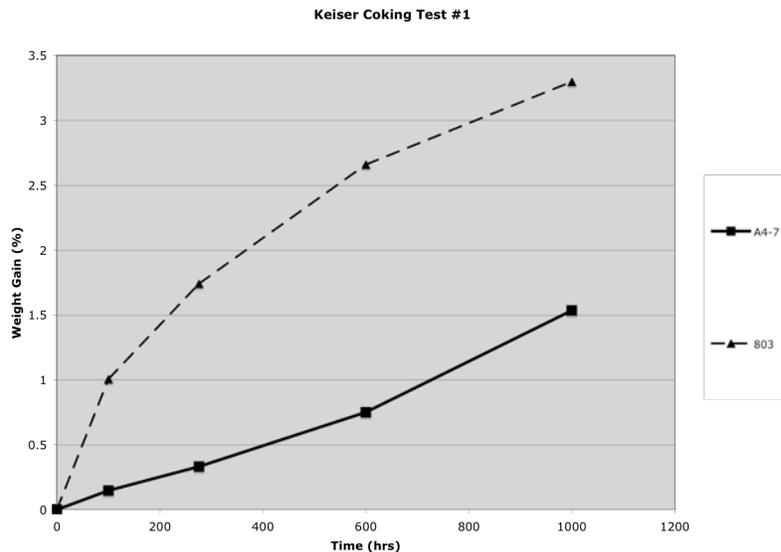
Figure 10. Coking and carburization test results. Weight gain for the uncoated I 803 steel coupon is significantly greater than for the coated coupon.

Figure 10, below, shows the measured weight gains for the typical petroleum refinery tubing alloy, I803, with and without the C3 nanofilm. Here the weight pickup of the coated steel sample is seen to vary from about 80% less at 200 hours to about 50% less at 1000 hours.

Most of this weight gain is from carburization, as will be shown later, but some coke deposition is also evident. SEM examination of the tested coupon surfaces showed copious carbon deposits.

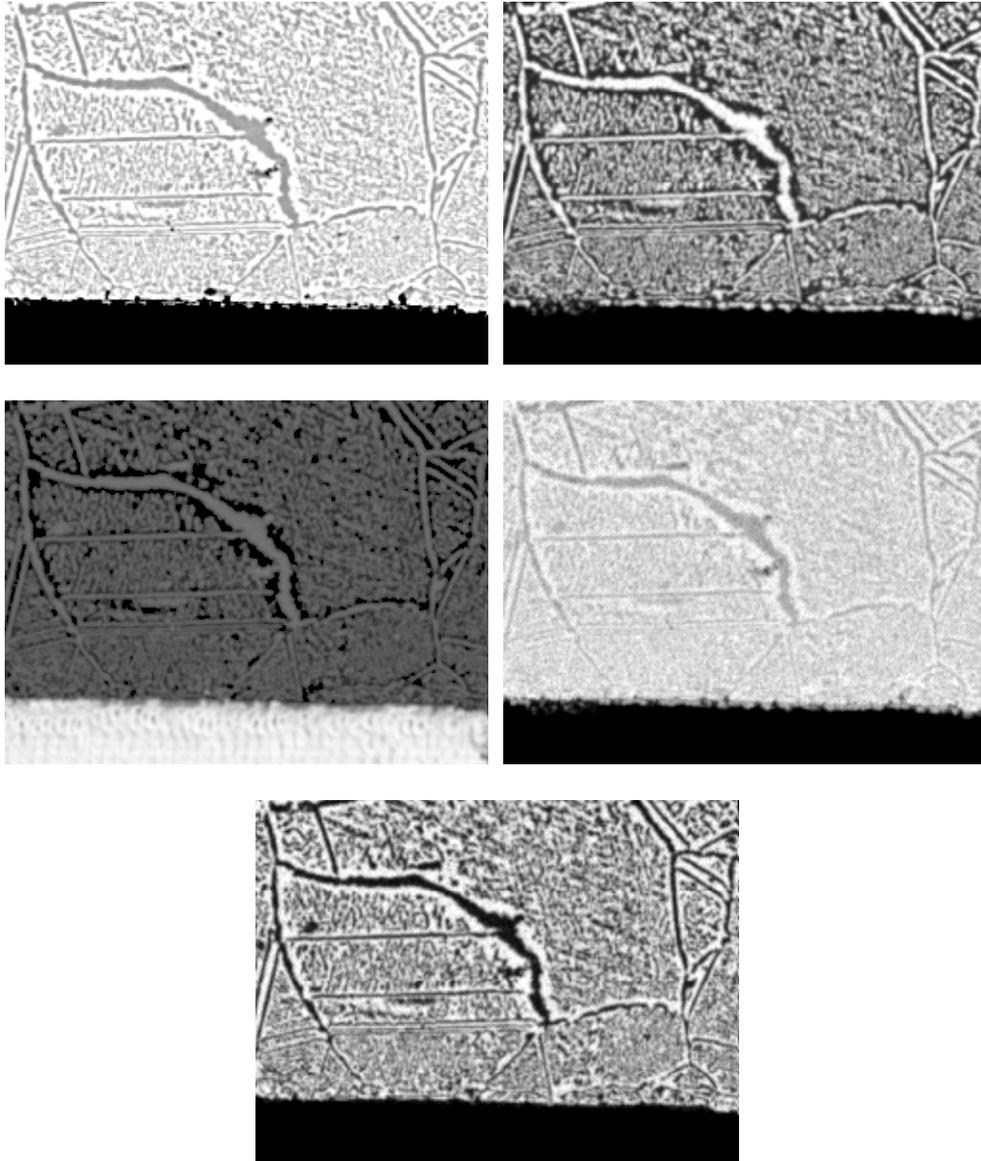
Figure 11. Electron microprobe results for uncoated alloy I803 specimen. Top left: BSE image. Top right: Cr image. Middle left: C image. Middle right: Fe image. Bottom: Ni image.

image of the uncoated alloy I803 specimen is presented in Figure 11, along with corresponding wavelength-dispersive x-ray analytical elemental photographs.

The microstructure of the alloy has been radically altered by the exposure to the methane/hydrogen mixture, with large amounts of carbon having been absorbed and converted into chromium carbides both in the grains and grain boundaries.

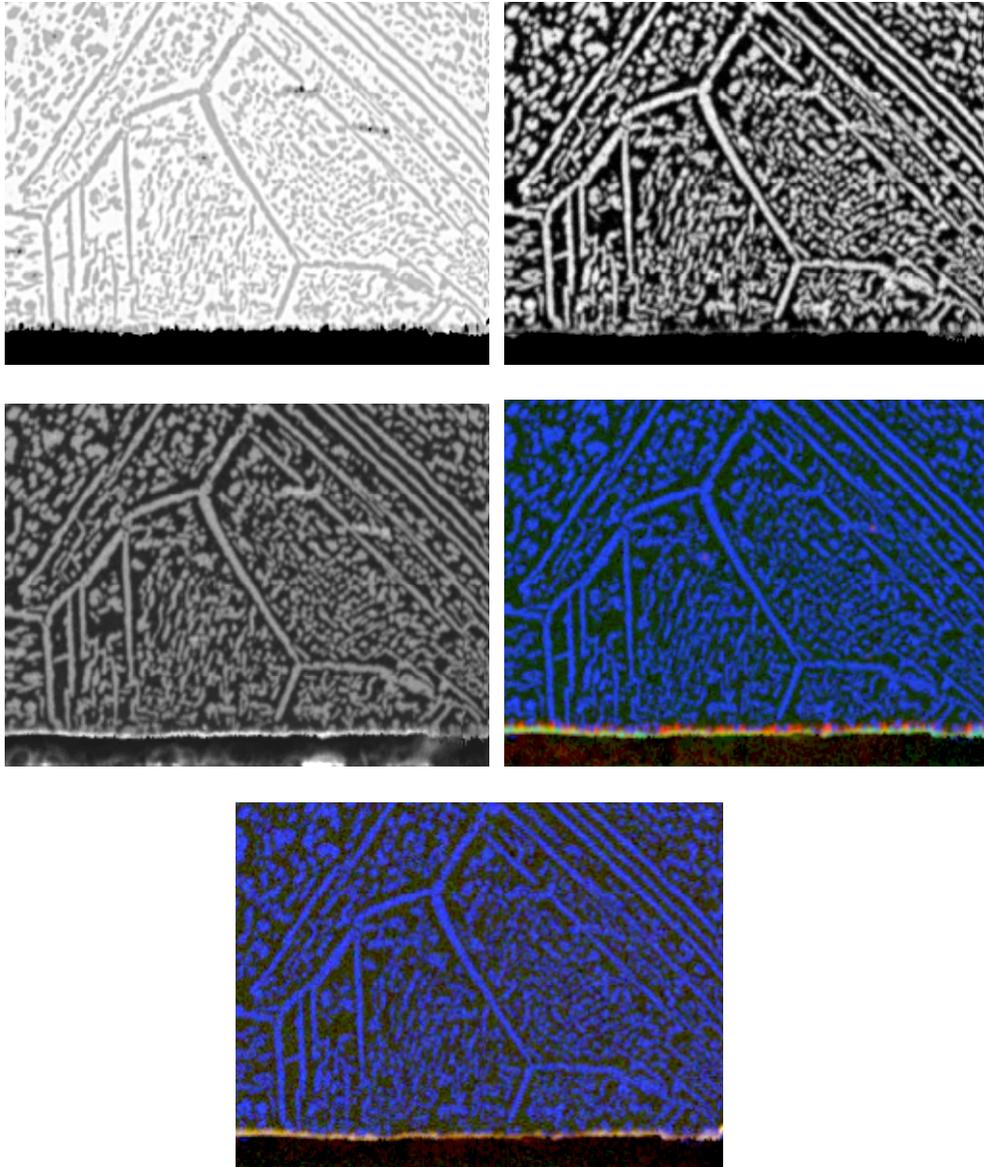
Figure 12. Electron microprobe results for stabilized zirconia-coated alloy I803 specimen. Top left: BSE image. Top right: Cr image. Middle left: C image. Middle right: O-Zr-Cr image. Bottom: Zr-REE-Cr image.

Electron microprobe analyses of the stabilized zirconia-coated specimen yield similar results: chromium carbides are found throughout the alloy internal structure (Figure 12), and chromium is found at the specimen surface along with Zr, REE, and O.

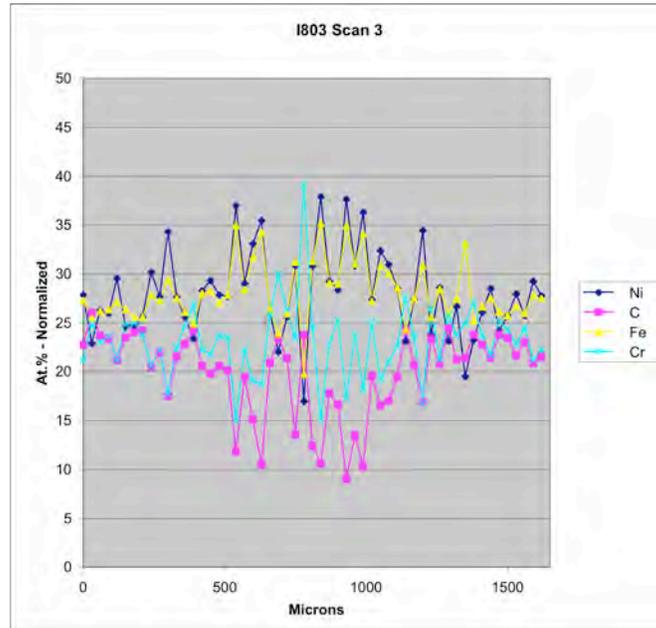
Figure 13. Microprobe results on an uncoated I803 alloy specimen exposed to 99% H₂/1 % CH₄ at 900°C for 1000 hours. Significant carbon pickup is noted, with nearly one atom in five in the structure being replaced by carbon.

First is illustrated one of the scans (the third of each set of four) from each of the uncoated alloy (Figure 13) and a coated specimen (Figure 14).

The uncoated alloy specimen shows high carbon levels throughout the specimen, while the coated specimen shows a much lower carbon level and more uniform levels of Cr, Ni, and Fe through the center of the specimen than the uncoated specimen.

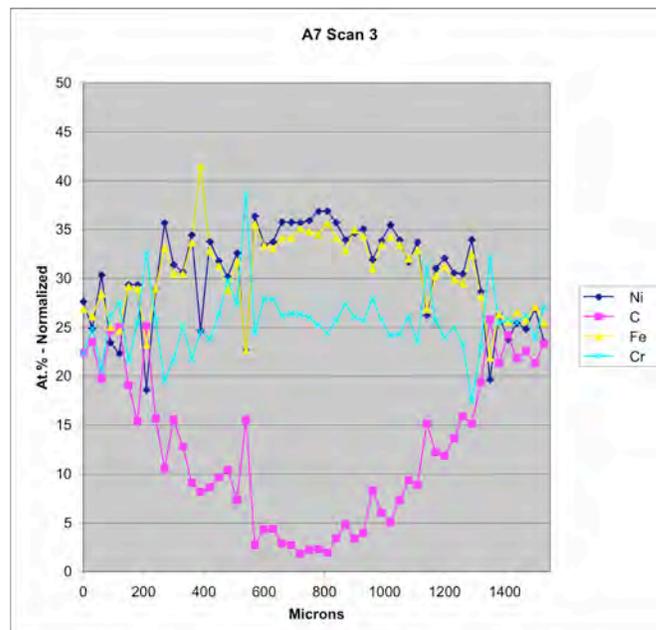
Figure 14. Microprobe results on a stabilized zirconia-coated I803 alloy specimen exposed to 99% H₂/1 % CH₄ at 900°C for 1000 hours. Carbon pickup is much reduced from the previous specimen.
