Coking and Carburization Resistance of an Engineered Oxide Nanofilm for the Petrochemical and Refining Industries

Arvid Pasto¹, James Keiser², Chaitanya Narula², Evan Hyde¹, Morgan Spears¹, Mark Deininger¹, and Michael Pozvonkov¹

An engineered nanofilm of ceria-stabilized zirconia, applied to an industry-standard alloy for use in coker heaters, is shown in a 1000 hour/900°C test performed at Oak Ridge National Laboratory (ORNL) to reduce the extent of coking and internal metal carburization. Weight gain from the coke deposit and the internal carburization is reduced by approximately 50 %. Data from scanning electron microscopy of the external surfaces, and optical metallography and electron microprobe analysis of cross-sections, show that the several hundred nanometer-thick film remains intact, although there appears to have been chromium migration through it. Other compositions of nanofilm were not as successful at blocking coking and carburization, however.

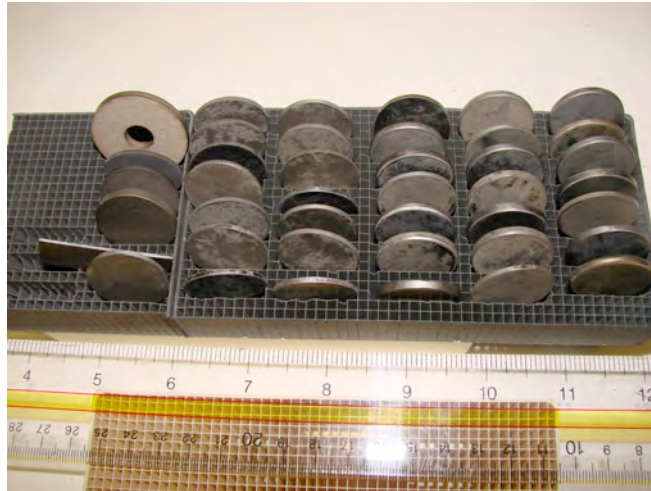
Photographs of the specimens in their carrier, both before and after the 1000 hour exposure, are provided below.

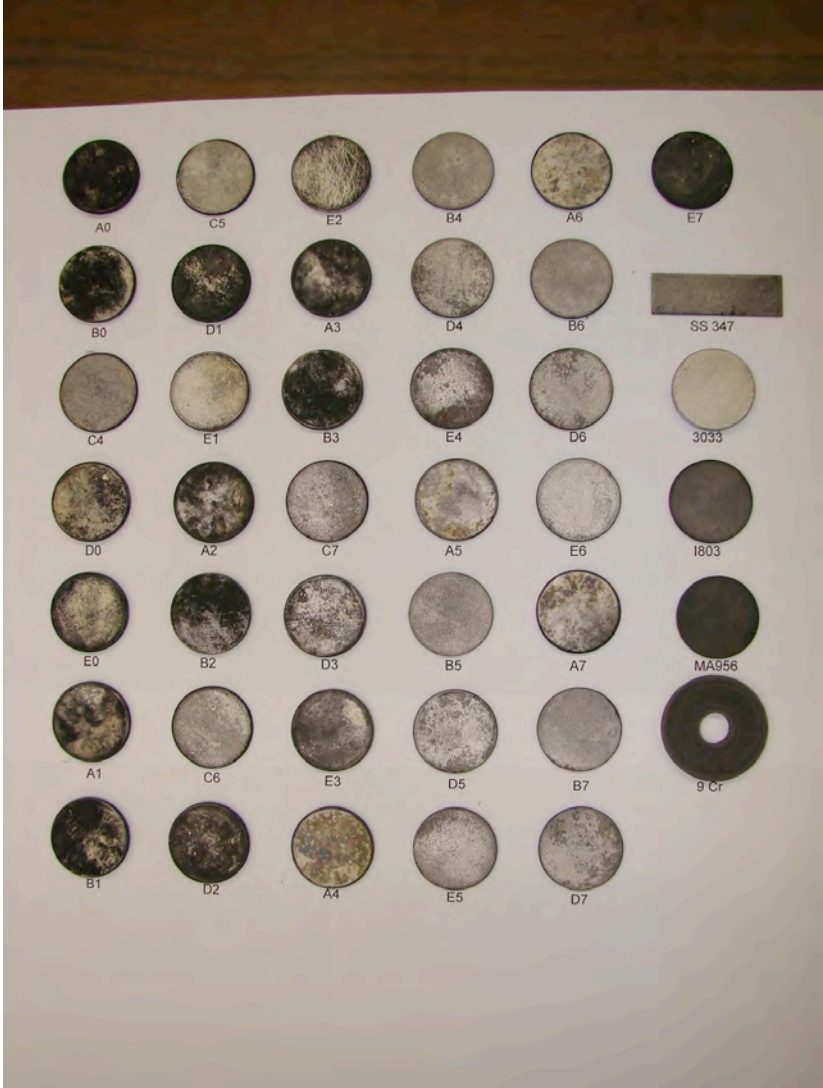
A photograph of all of the specimens after removal from the test is provided below, in which distinct differences in their appearances are observable. These variations arise from the carbon deposited on them. There were not large observable differences between the ceria/zirconia-coated specimens and those of the other types coated onto alloy I803, in general. Specimens A5 and C5 are shown below in a closer view, and it is apparent that there has been more deposition on the edges of the specimens than the faces, and some of the coatings had pin-hole defects in them.

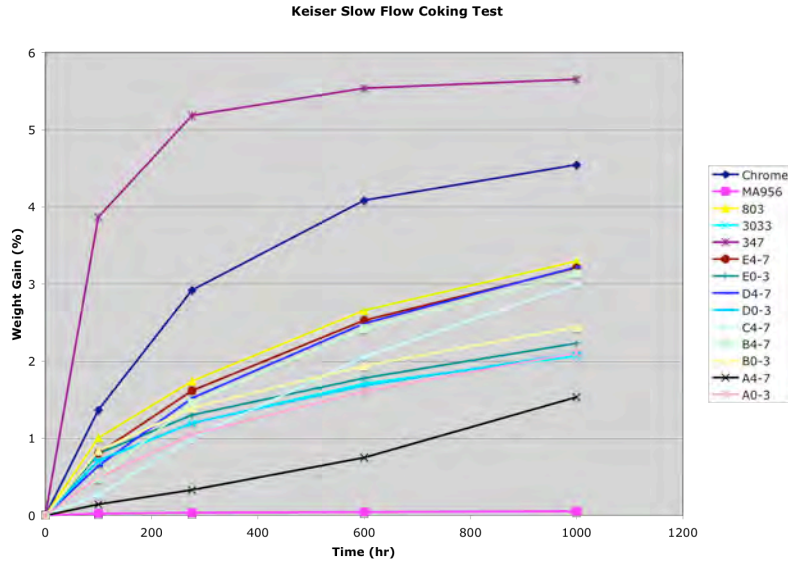
Weight gain data for all of the materials is plotted in the following figure, showing that most of the materials exhibit a rapid initial weight gain followed by a diminishing rate of change. Alloy MA956, known for its low coking and carburization rate, is the slowest at gaining weight, followed by the A4-A7 specimen set. This latter set of materials also

exhibits an unusual behavior, starting off slowly then gaining weight more rapidly. Evidence to be presented later suggests that this is due to the initially-protective zirconia film ultimately becoming breached by the outward migrating chromium from the I803 alloy.

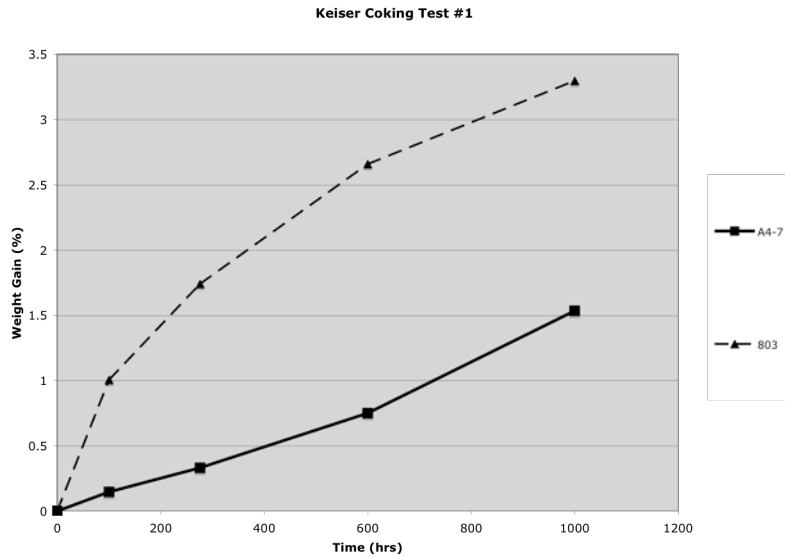
The performance of uncoated alloy I803 is plotted along with that of the A4 – A7 specimen set in the following figure, where the weight pickup of the latter is seen to vary from about 80% less at 200 hours to about 50% less at 1000 hours.

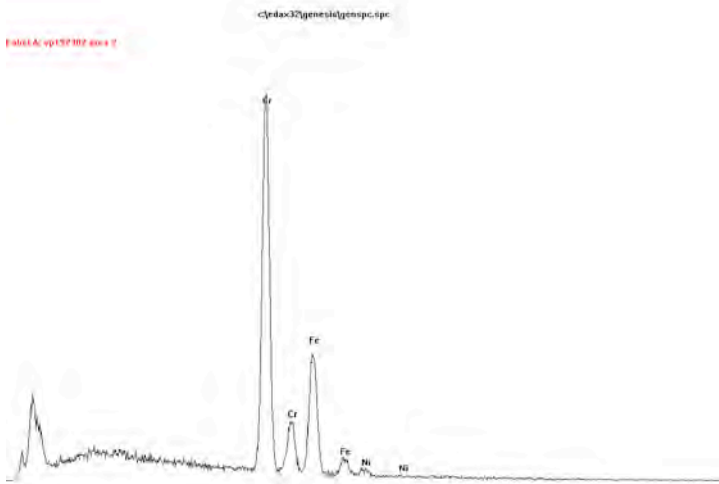
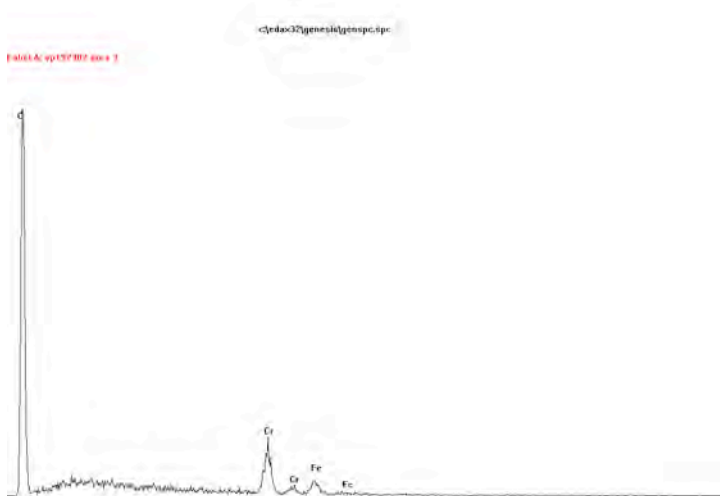
EDX analysis of four regions (areas 1 – 4) is presented below. The brightest region (1) yields a preponderance of Zr, with Ce, Cr, Ni, Fe, and O, showing that the CeZr oxide coating remains. The Fe-Ni-Cr alloy underneath is also detected, meaning that either

these elements have migrated through the film, or the electron beam has penetrated the film and excited x-rays from the underlying material, or the film has begun diffusing into the alloy. Electron microprobe results to be presented later argue against the last possibility. The second brightest region (2) is preponderantly Cr, with small Fe and Ni. The third brightest area (4) is mainly C and Cr, with no evidence of the nanofilm apparent. This could be taken to mean that the film has been breached by outwardly migrating metal atoms. Similarly to the uncoated alloy, there are regions (3) that are mainly C, and these are likely the coke deposits.

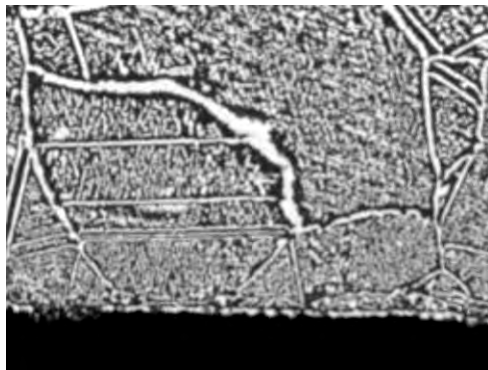
Specimens were mounted in epoxy, cut into two portions across their diameters, and polished for electron microprobe analysis. Several analyses were performed as described earlier. A BSE image of the uncoated alloy I803 specimen is presented below, along with

The microstructure of the alloy has been radically altered by the exposure to the methane/hydrogen mixture, with large amounts of carbon having been absorbed and converted into chromium carbides both in the grains and grain boundaries.

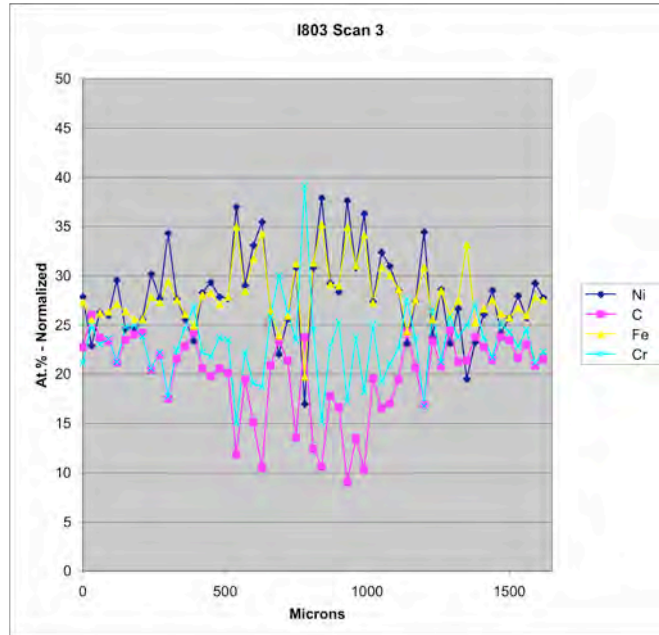
I803

The uncoated alloy specimen (first figure) shows high carbon levels throughout the specimen, while the C5 specimen (second figure) shows slightly lower carbon levels with more of a trough (less carbon in the specimen center).

First is illustrated one of the scans (the third of each set of four) from each of the uncoated alloy, an aluminosilicate/CeZr coated specimen: C5), and a CeZr coated specimen (A5).
